SPECIAL AIRWORTHINESS INFORMATION BULLETIN

CE-05-78
August 4, 2005

This Special Airworthiness Information Bulletin (SAIB) alerts you, owners and operators of **Amateur-Built Experimental IAR SA BRASOV Model IAR823** airplanes, of the need to inspect the canopy latching rods for proper alignment and wear.

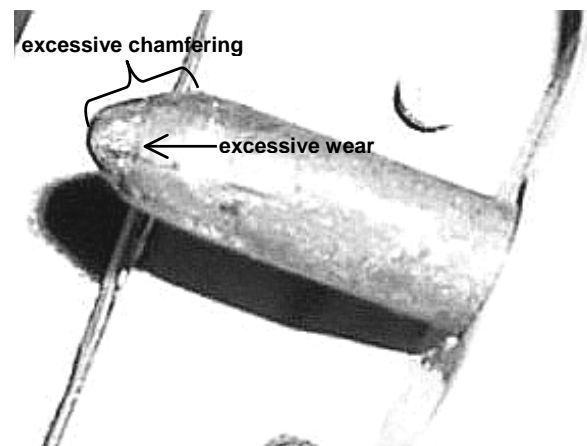
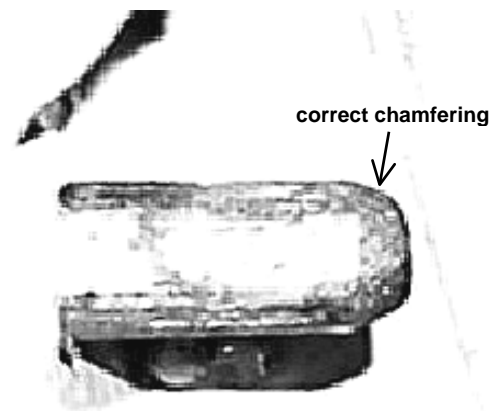
During the investigation of an incident, our Flight Standards Division noted excessive wear and excessive chamfering on the end of the forward latching rod on the left side of the canopy. The end of the latching rod was incorrectly chamfered to greater than three-fourths the diameter of the rod causing the striker to ride on the chamfered end of the rod instead of the flat side of the rod. This created a force pushing the rod out of the striker, which allowed the canopy to unexpectedly open during flight and resulted in the Plexiglas in that section of the canopy breaking and departing the aircraft.

We recommend that owners and operators of all amateur-built experimental IAR SA BRASOV Model IAR823 airplanes inspect the canopy latching rods for correct chamfering. Correct chamfer of the latching rod is one-third of the diameter the rod.
